New York State Department of Transportation

Red Flag NB2258W015

BIN: 1065318

Location: Span 68, Stringer S1 at Pier 67 above 3rd Avenue EB Service Road at the intersection of 58th Street.

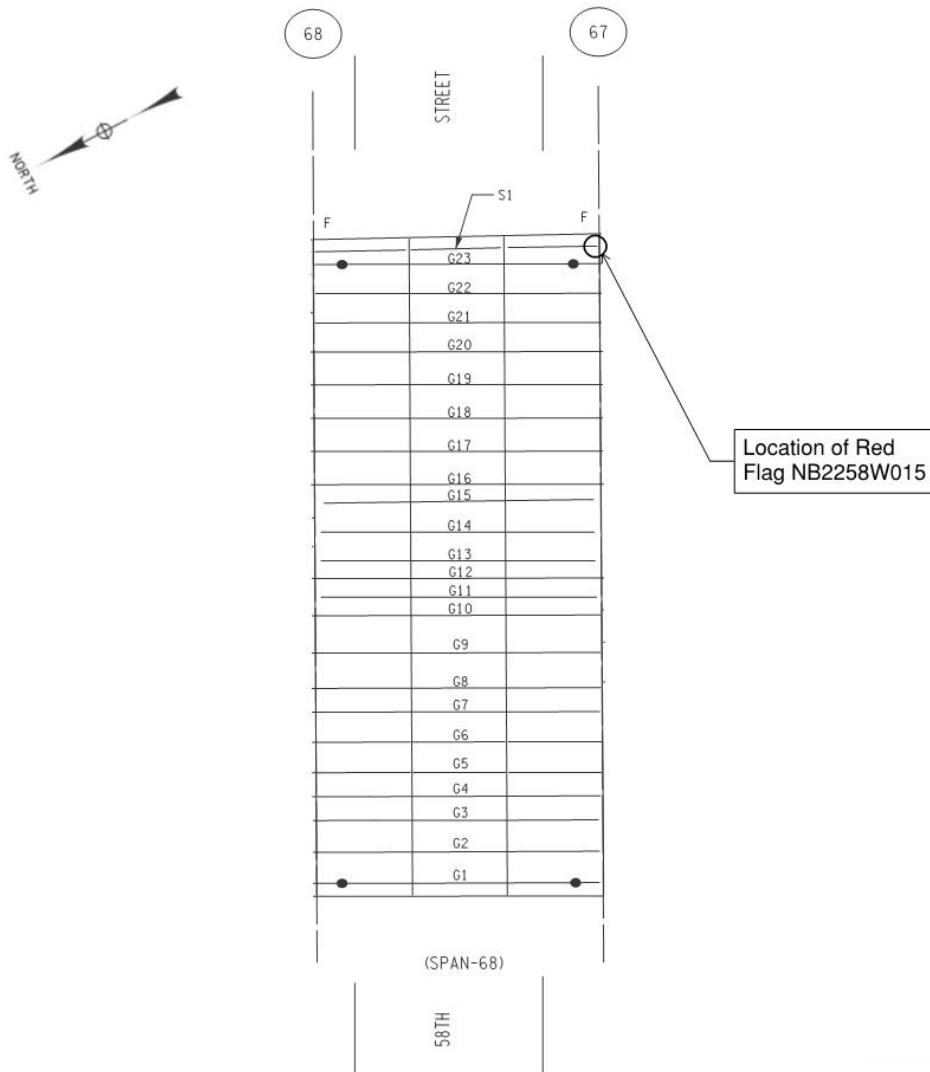
Flag PhotographsPhoto Number: **1**Photo Filename: **22_Flag Location Plan.jpg**Gowanus Expressway
2022 Biennial Inspection - Field SketchBIN: 1065318Team: AA/TSDate: 09/22/2022Span: 68Location: Stringer S1 at Pier 67**Red Flag Location Plan**

**wsp****Attachment Description: Red Flag Location Plan**

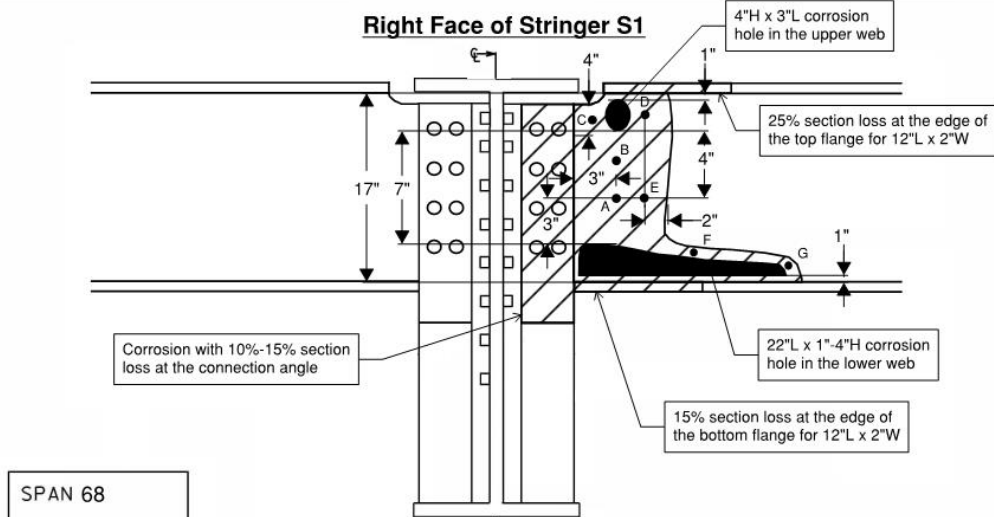
Photo Number: 2

Additionally, the edge of the bottom flange exhibits section loss up to 25% at the left side and 15% at the right side for 12"L x 2"W (Photo 8). The right side top flange exhibits 25% section loss at the edge of the flange for 12"L x 2"W (Photo 9). Also, both connection angles exhibit corrosion with 10%-15% section loss. (refer to Red Flag Condition Sketch Photo 2 for more details)

SPAN 68
@ PIER 67
S1

Point	D-Meter Readings (in)	Calculated Section Loss
A	0.17	58%
B	0.12	70%
C	0.16	60%
D	0.16	60%
E	0.21	48%
F	0.21	48%
G	0.23	43%

Section loss Calculations:

Original web thickness = 0.40" (measured in field)

Shear web area:

$$(0.17 \times 1") + (0" \times 4") + (0.17 \times 3") + (0.12 \times 4") + (0" \times 4") = 1.16 \text{ in}^2$$

Overall shear web area section loss:

$$[(16" \times 0.40") - 1.16 \text{ in}^2] / (16" \times 0.40") \times 100 = 82\% \text{ section loss}$$

- The left side bottom flange of the stringer exhibits up to 25% section loss at the edge of the flange for 12"L x 2"W.
- The length of this portion of Stringer S1 between Pier 67 and ID1 is approximately 17ft.
- The distance from the edge of the roadway to the right fascia steel plate is approximately 26".
- The distance from the right face of the Stringer S1 web to the right fascia steel plate is approximately 31".

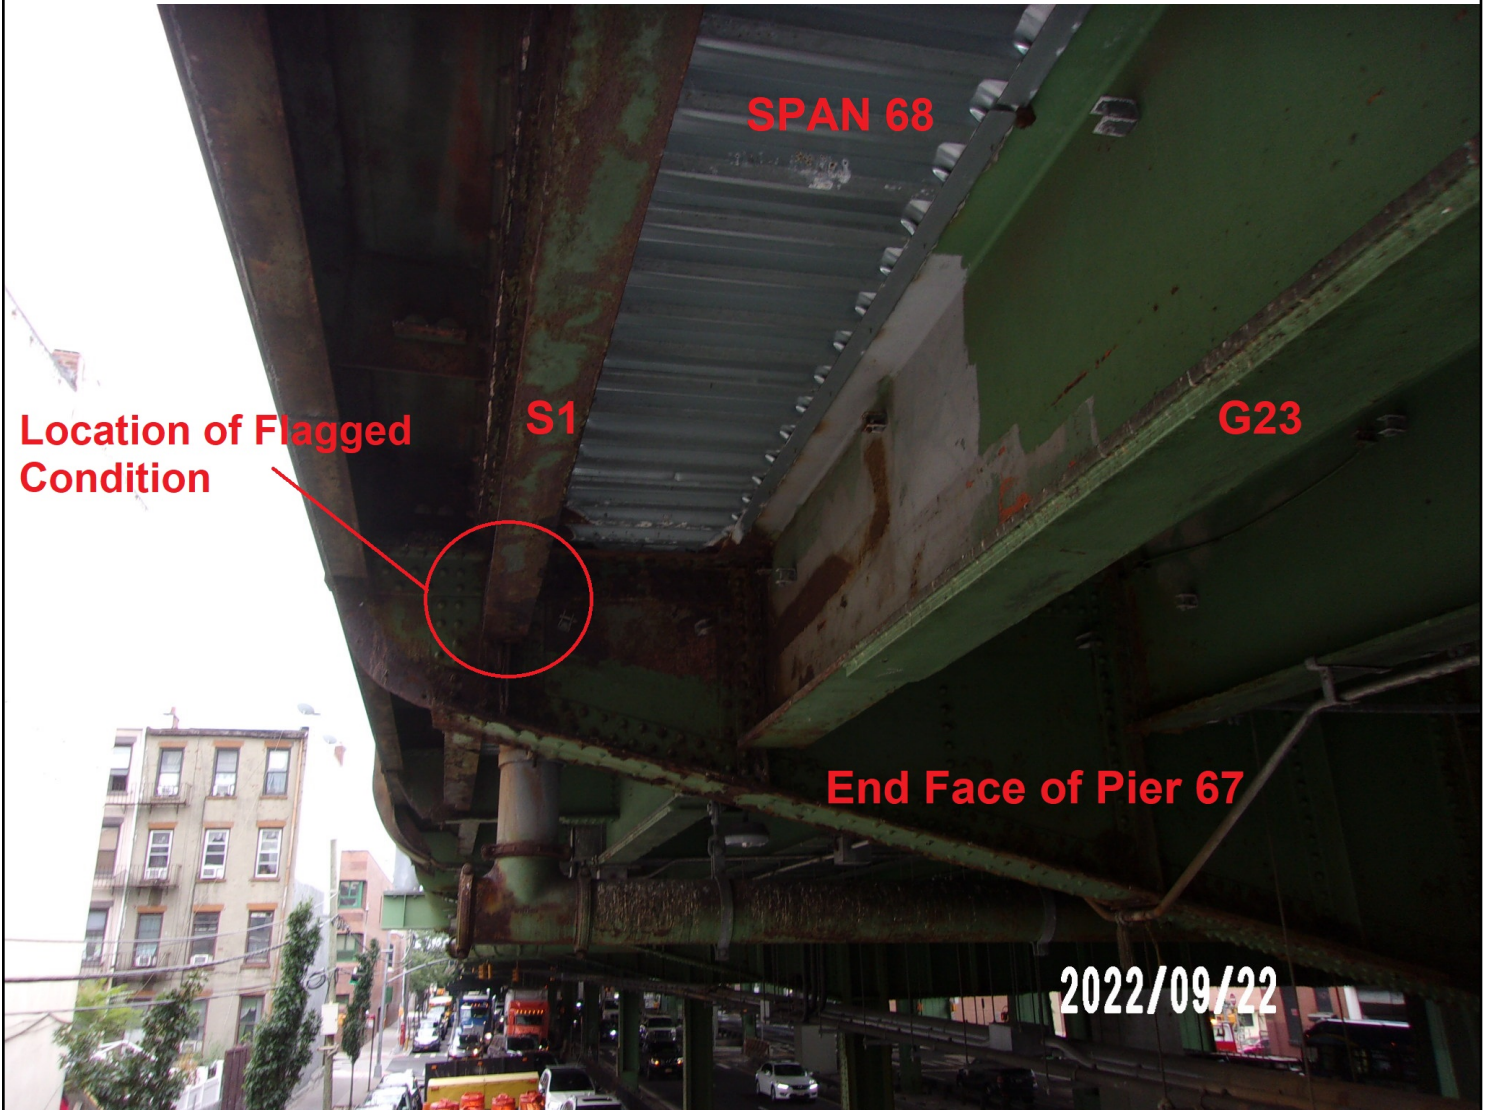
Photo Number: 3

Attachment Description: General view of the flagged condition at Stringer S1 in Span 68 at Pier 67. Looking Begin.

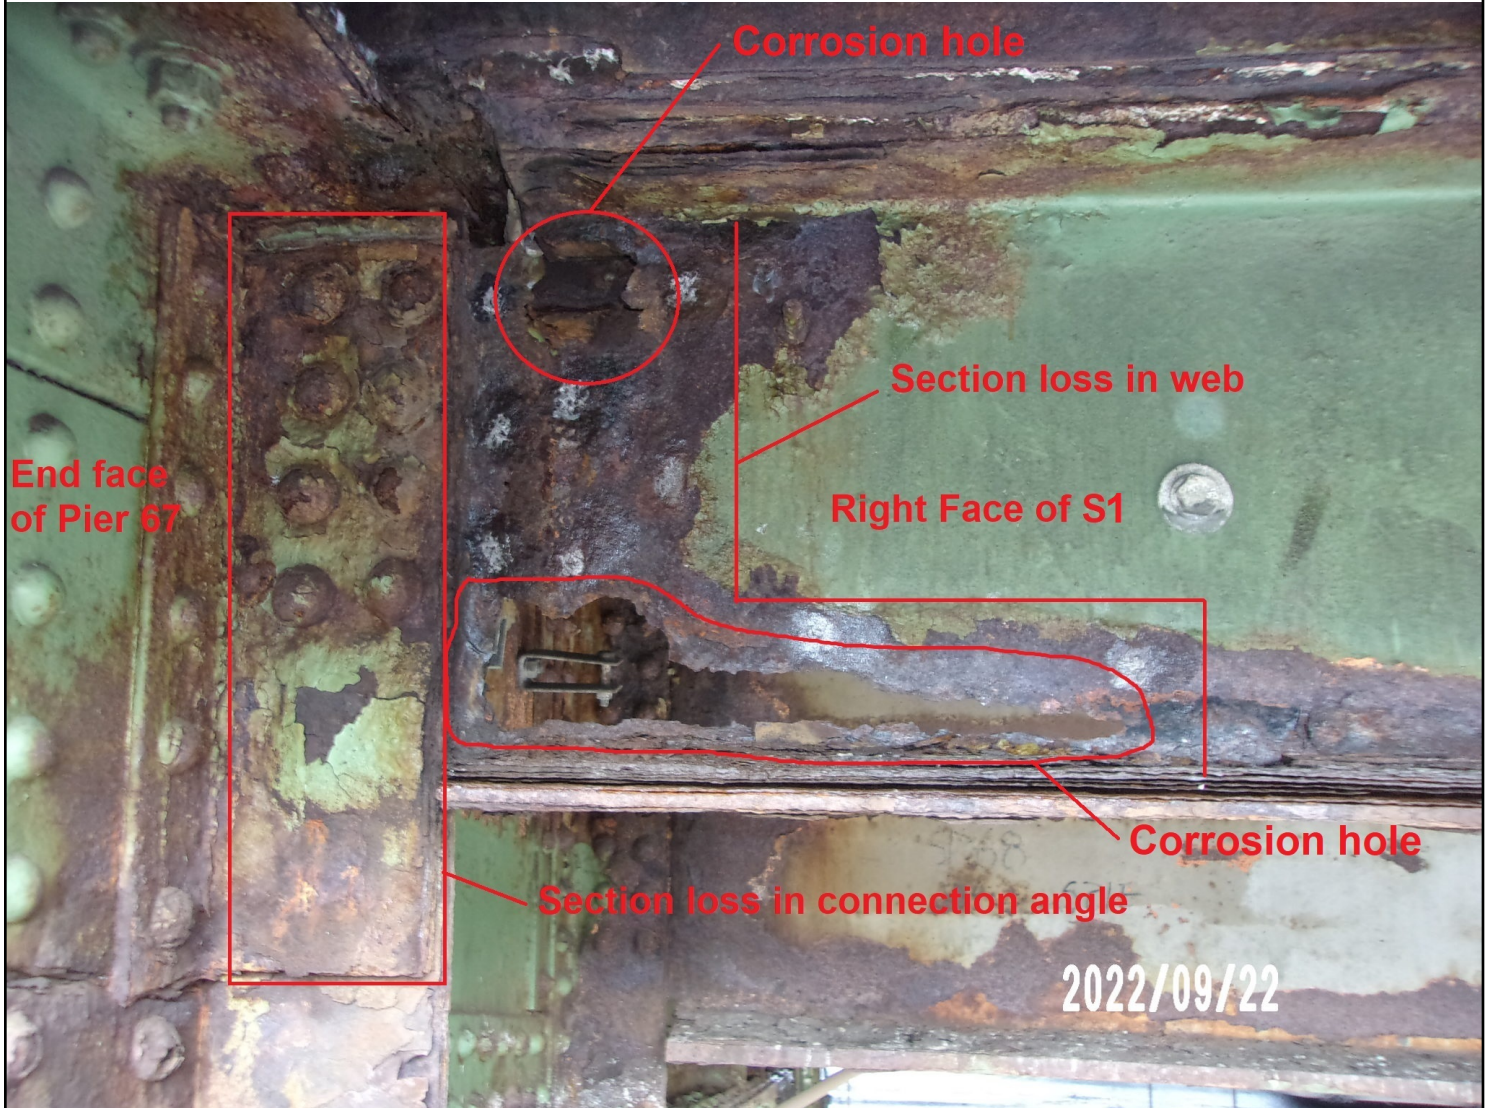
Photo Number: 4

The end of Stringer S1 in Span 68 at Pier 67 exhibits section loss for the full web height for 7" wide along the connection angles with remaining thickness measured (RTM) ranging from 0.12" to 0.21" resulting in approximately maximum 70% section loss (Photos 4 and 5). The lower stringer web above the bottom flange exhibits one corrosion hole for 22"L x 1"-4"H with RTM ranging from 0.21" to 0.23" for 1" wide surrounding the hole resulting in approximately maximum 48% section loss (Photo 6). The upper stringer web exhibits one corrosion hole for 4"H x 3"L at the top cope (Photo 7). The overall shear web area section loss is approximately 82% for this fascia stringer/curb girder.

Attachment Description: The right face of Stringer S1 in Span 68 at Pier 67. The end of the stringer exhibits approximately 70% section loss for the full web height along the connection angle with one corrosion hole in the upper web and one corrosion hole in the lower web. Also, the connection angle exhibits corrosion with 10%-15% section loss. Looking Left.

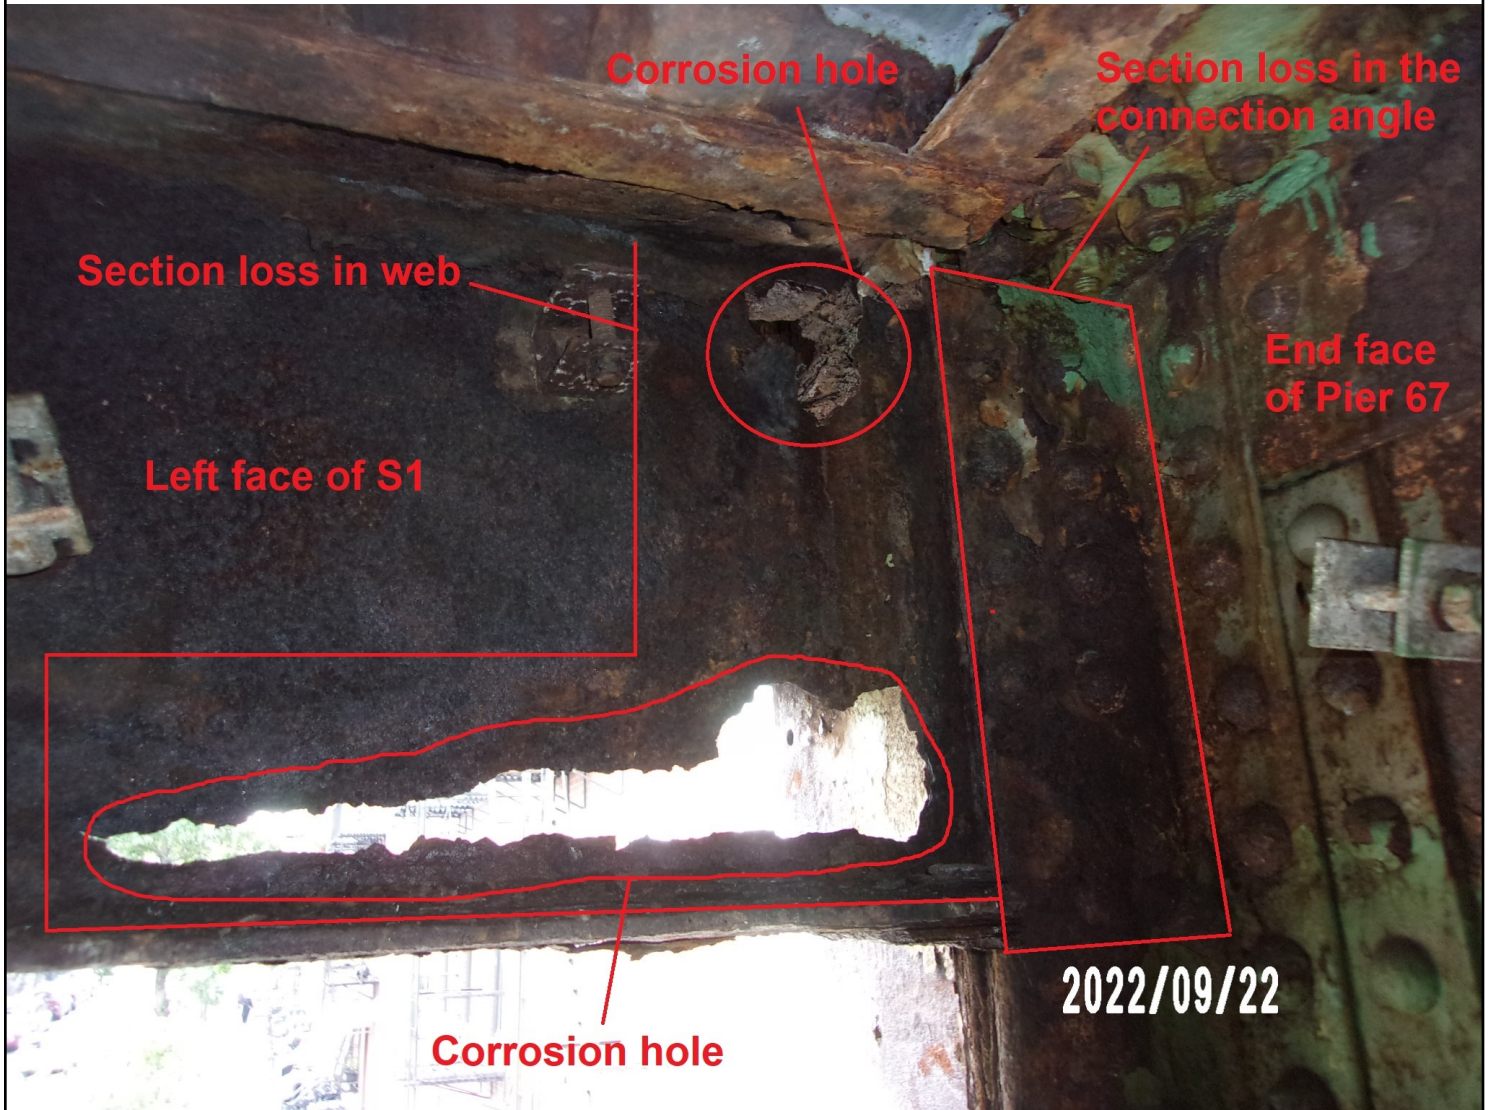
Photo Number: 5

Attachment Description: The left face of Stringer S1 in Span 68 at Pier 67. The end of the stringer exhibits approximately 70% section loss for the full web height along the connection angle with one corrosion hole in the upper web and one corrosion hole in the lower web. Also, the connection angle exhibits corrosion with 10%-15% section loss. Looking Right.

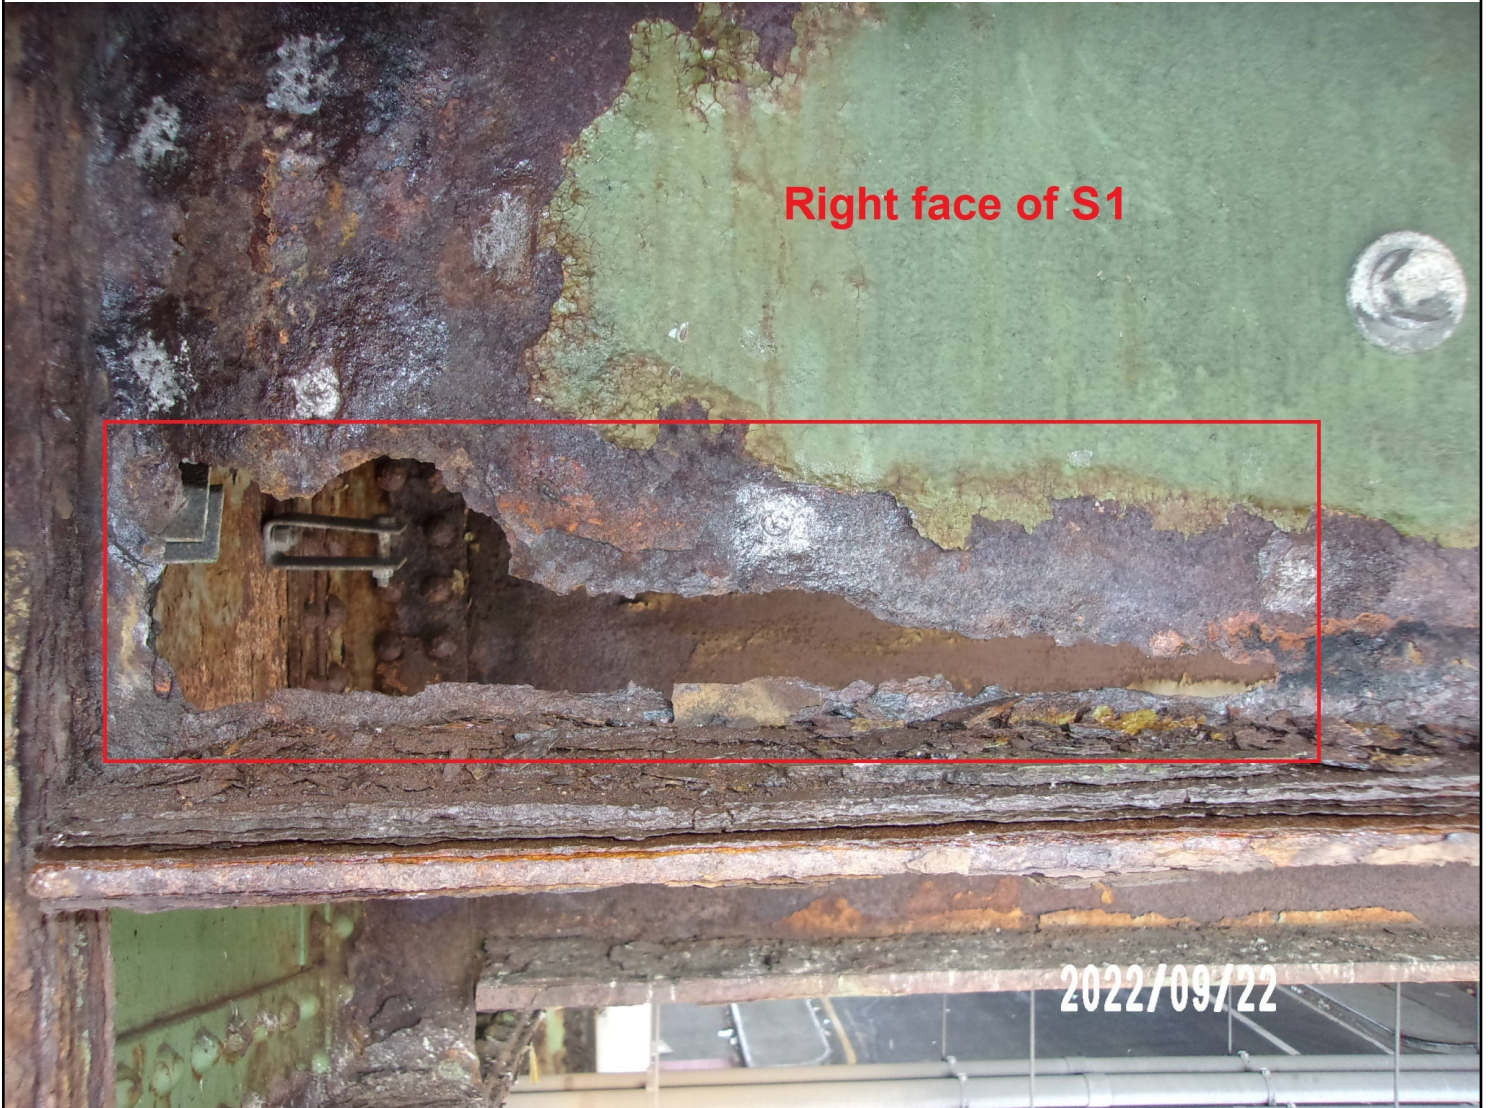
Photo Number: 6

Attachment Description: The right face of Stringer S1 in Span 68 at Pier 67. Close up view of the 22"L x 1"-4"H corrosion hole in the lower web above the bottom flange. Looking Left.

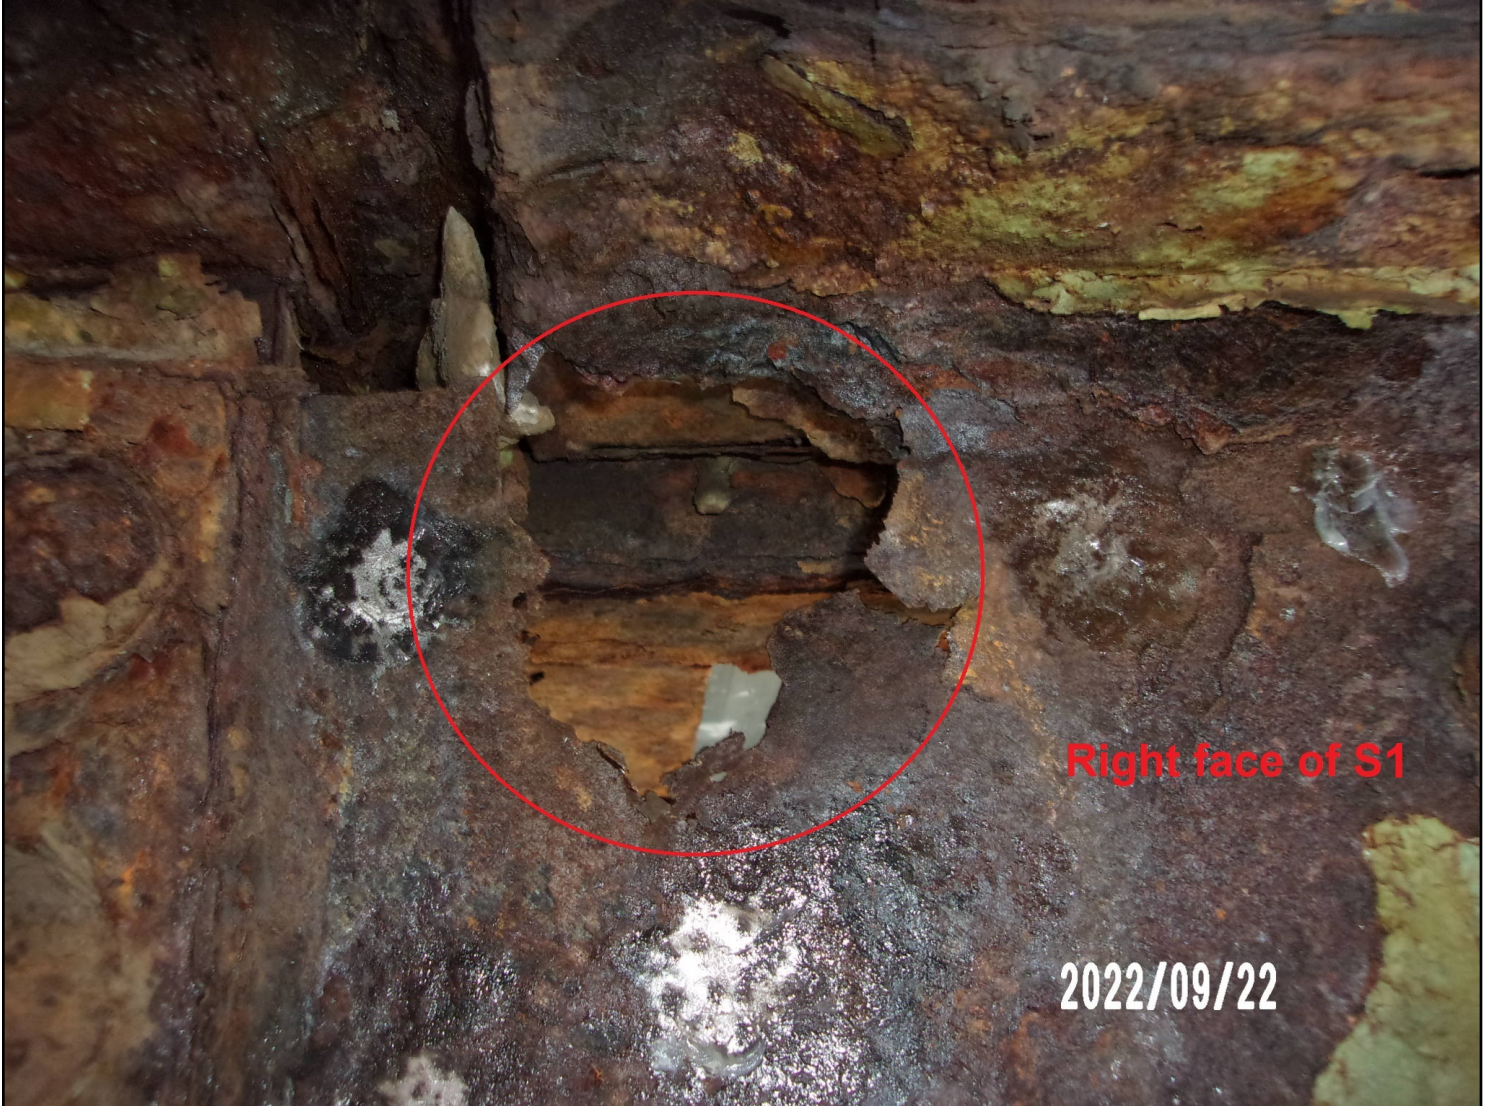
Photo Number: 7

Attachment Description: The right face of Stringer S1 in Span 68 at Pier 67. Close up view of the 4"H x 3"L corrosion hole in the upper web near the top cope. Looking Left.

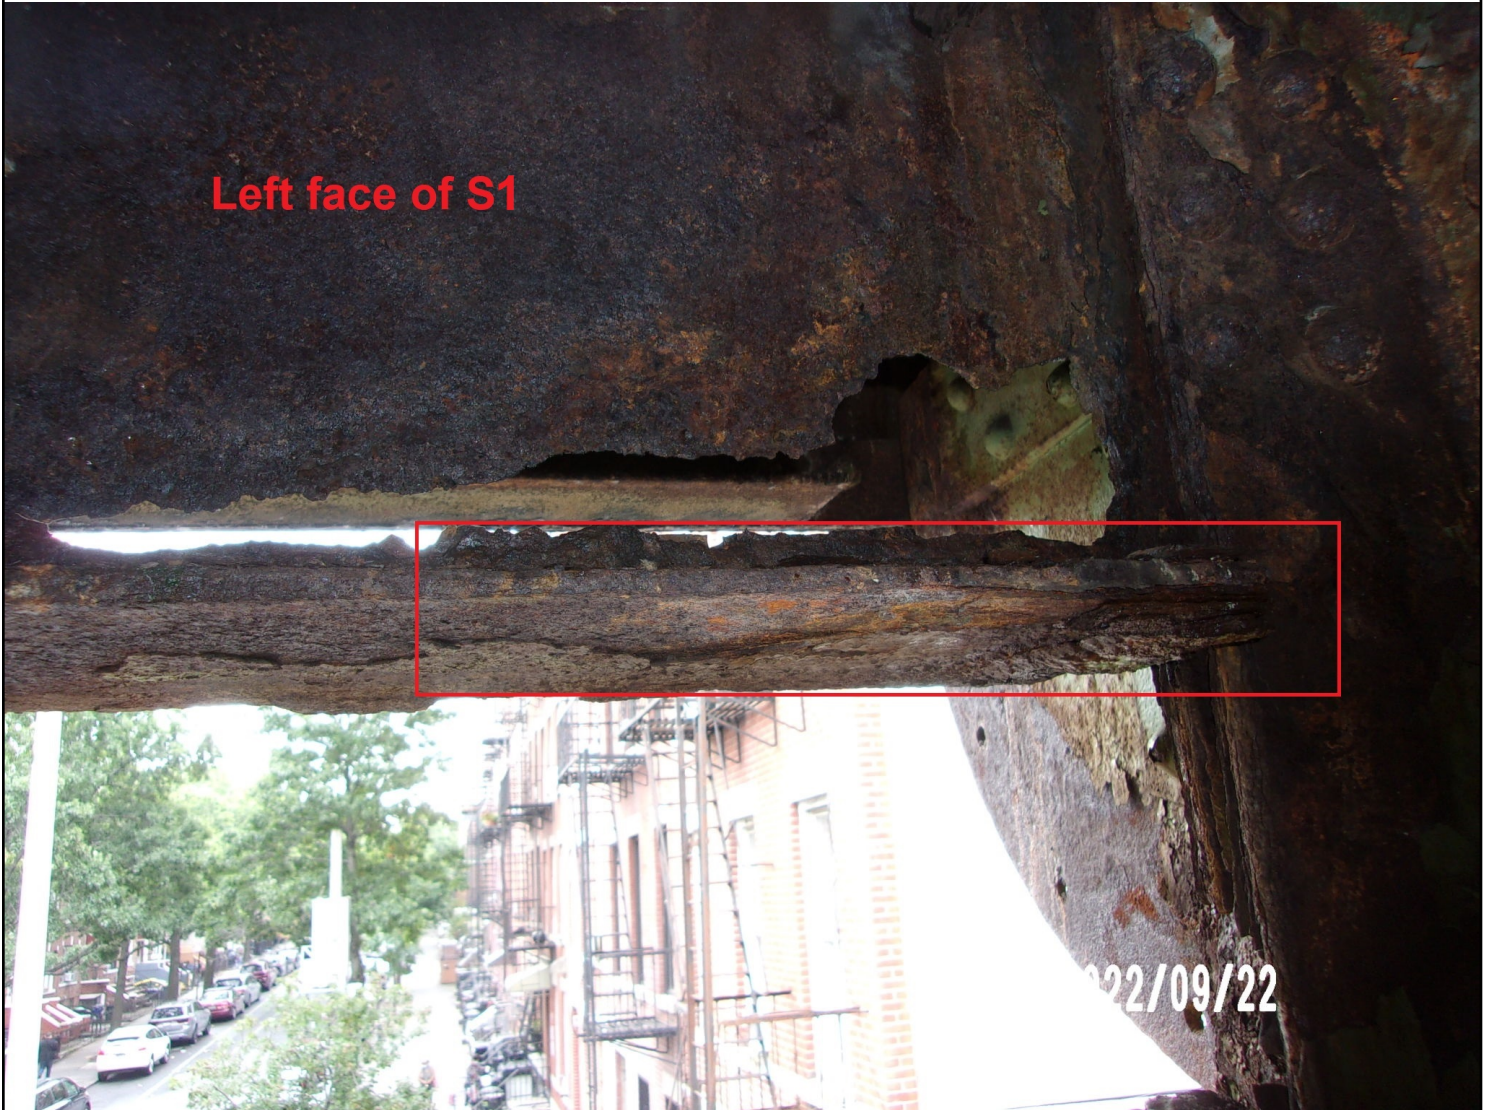
Photo Number: 8

Attachment Description: The left face of Stringer S1 in Span 68 at Pier 67. The edge of the bottom flange exhibits up to 25% section loss. Looking Right.

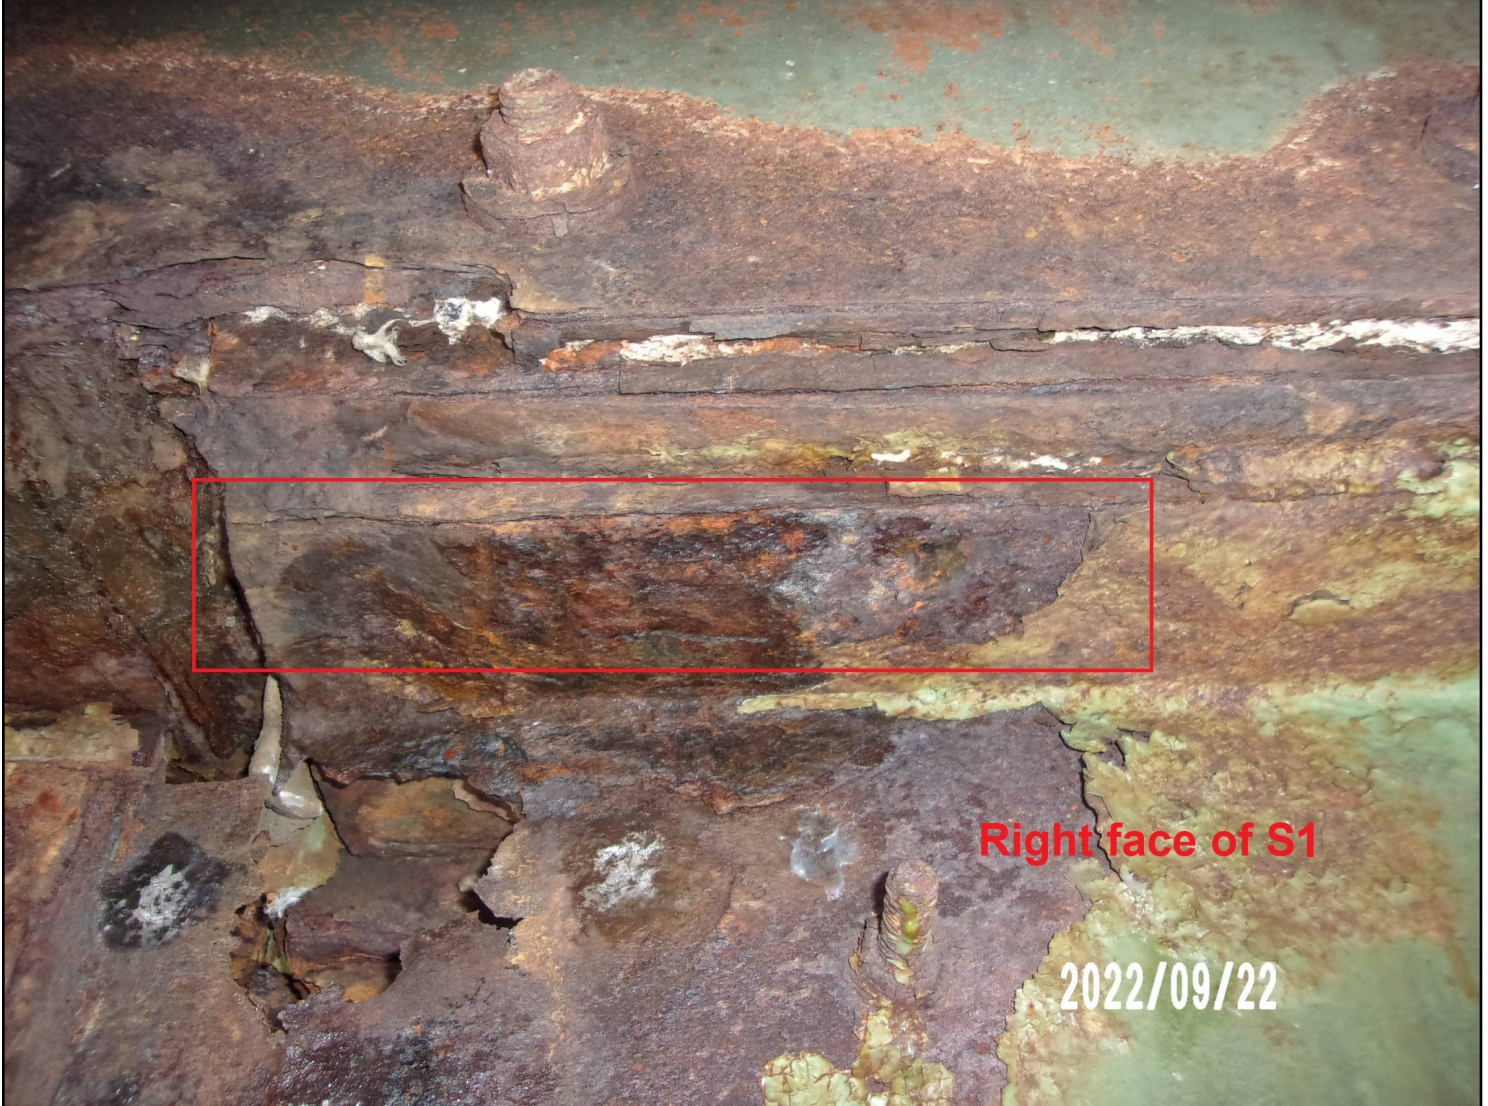
Photo Number: 9

Attachment Description: The right face of Stringer S1 in Span 68 at Pier 67. The edge of the top flange exhibits 25% section loss. Looking Left.

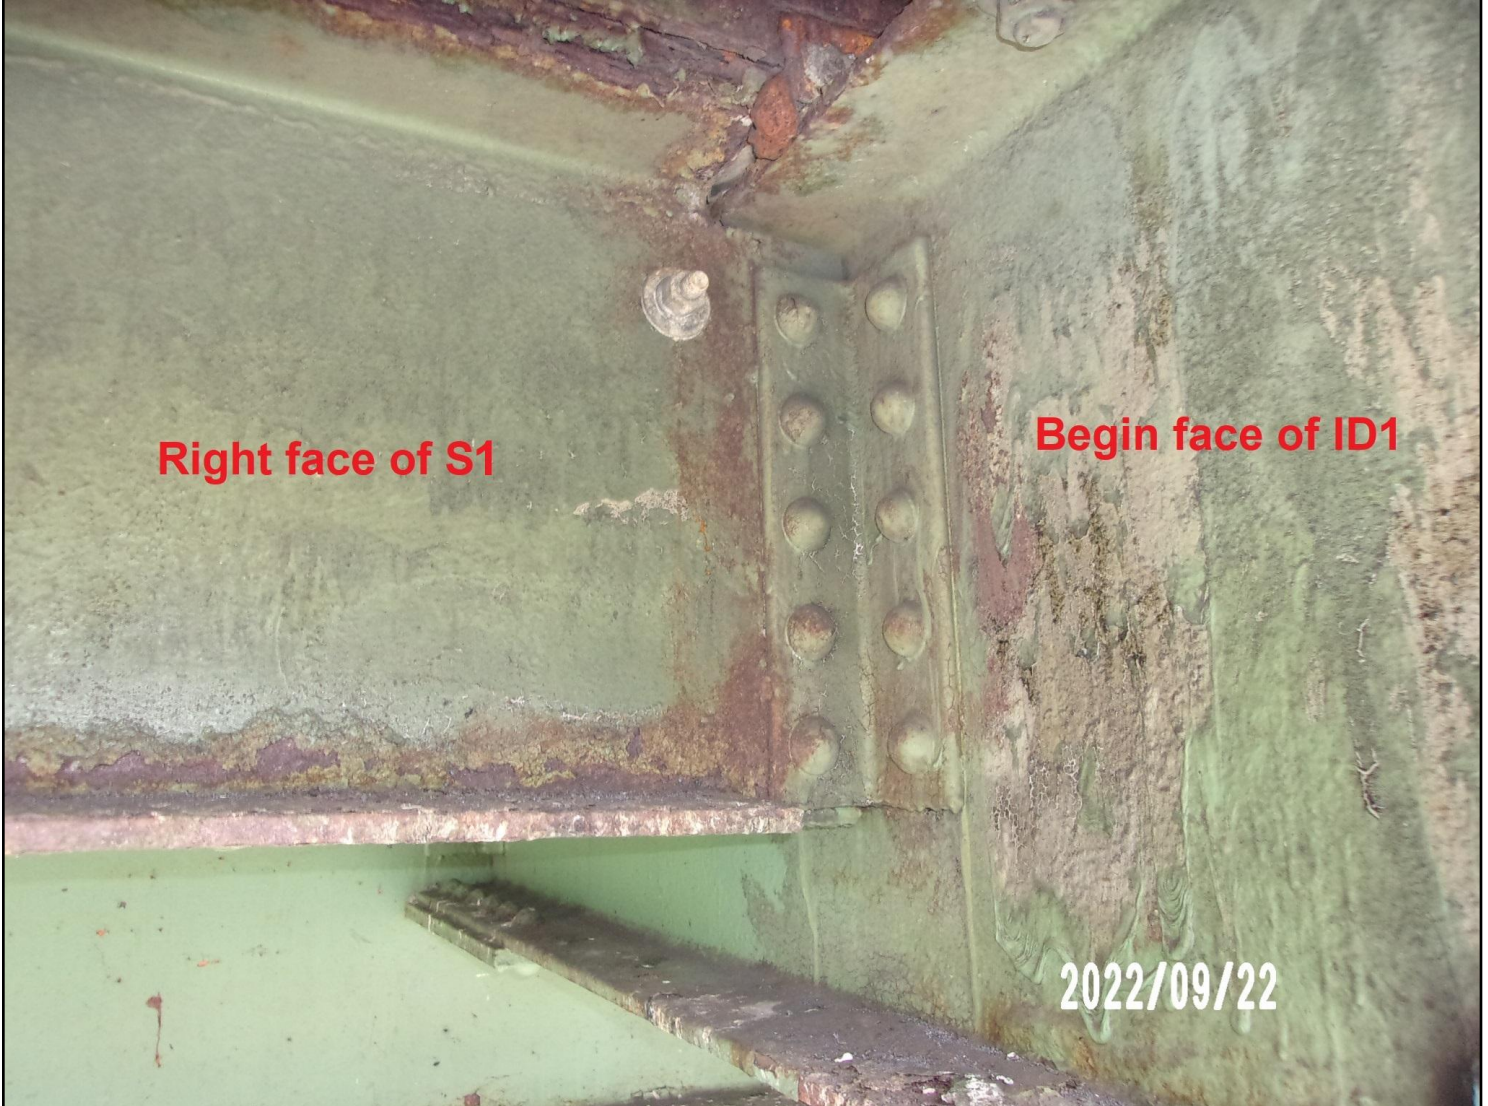
Photo Number: 10

This portion of Stringer S1 is approximately 17ft long from Pier 67 to Intermediate Diaphragm #1 (ID1). The stringer at the connection to ID1 exhibits no significant defects in the stringer web (Photo 10). Given the significant section loss in the stringer web at the connection angle at Pier 67, the stringer does not pose any safety concerns of falling onto pedestrians or vehicular traffic below at the time of inspection.

Attachment Description: The right face of Stringer S1 in Span 68 at Intermediate Diaphragm ID1. The end of the stringer at the connection angle to ID1 exhibits no significant defects. Looking Left.
